NAUGATUCK RIVER BASIN PLYMOUTH, CONNECTICUT

# PLYMOUTH RESERVOIR DAM CT 00286

PHASE I INSPECTION REPORT
NATIONAL DAM INSPECTION PROGRAM

**MAY 1981**

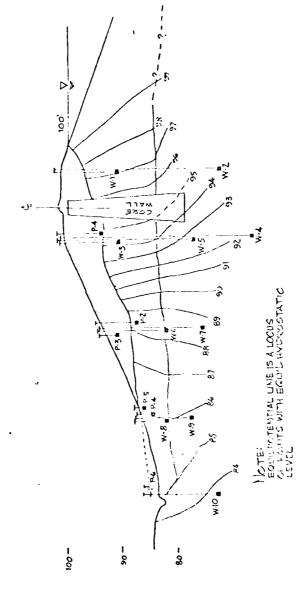
FIG. 3 DAM SECTION WITH EQUIPOTENTIAL LINES

The piezometers were read after completion and at periodic intervals thereafter to assure that an equilibrium condition had been reached. Using data taken July 1, 1975, equipotential lines have been superimposed on the dam section and are presented in Figure 3.

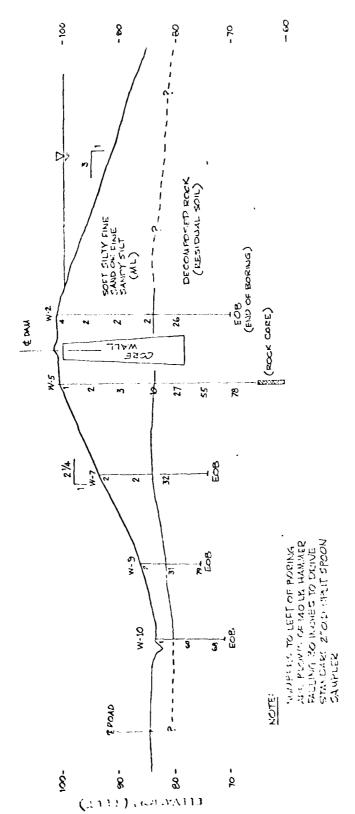
FIG. 2 DAM SECTION SOFT. SOUTH OF SPILLWAY

Figure 2 is a section through the dam showing the soil condition and blow counts encountered. The configuration of the dam slopes was determined by actual measurements extending about 85 feet on either side of the dam center line. Note that the downstream slope plots about 2-1/4 to 1 while the upstream slope plots about 3 to 1. It is suspected that during either the 1910 or 1921 work on the dam the upstream face was flattened to its present slope.

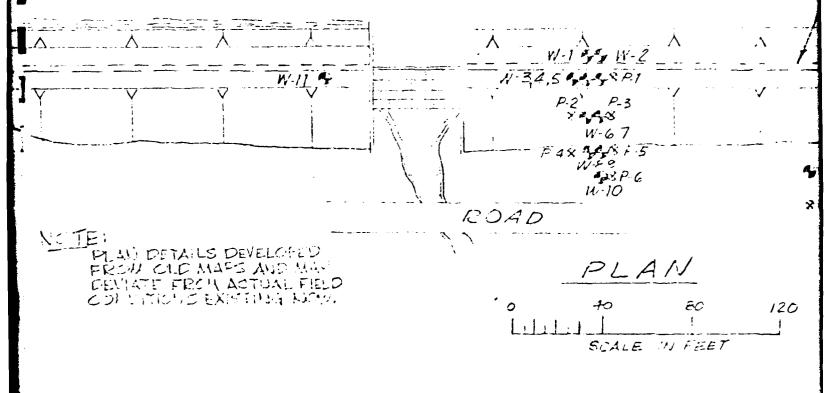
FIG. 1 SITE PLAN BORNO LOCATIONS 869.0136

Figure 1 shows a plan of the dam and the location of the various borings. The boring logs prepared by Associated Boring Company are attached at the end of this letter and give the drillers' description of the soil encountered.

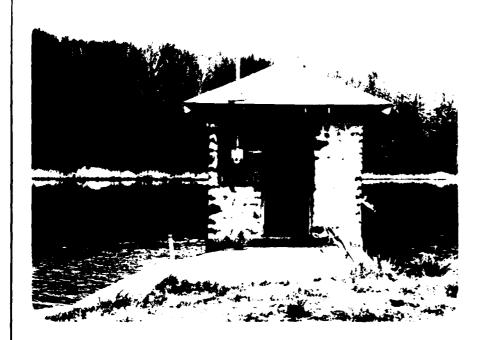
PHOTO NO. 9

The outlet works consist of a gatehouse located at the left end of the spillway and a 12-inch supply main and 10-inch low level outlet or blowoff through the dam. The stone masonry of the gatehouse appears to have been recently mortared and to be in good condition, Photo 9. The working condition of three manually operated intake gates is unknown. The low level outlet or blowoff and the supply main are normally controlled by gates located downstream of the road near the filter plant. The gatehouse also contains a screen chamber and compressor for an aeration system, Photo 10. The low level outlet or blowoff discharges through a 10-inch asbestos cement pipe approximately 200 feet below the dam, Photo 11.
